Inspection Report

PROPERTY INSPECTION REPORT

Prepared For:				
	(Name of Client)			
Concerning:				
	(Address or Other Identification of Inspected Property)			
Ву:	Travis L. Hooper 20776 / SEI Inspections	5/25/2016		
	(Name and License Number of Inspector)		(Date)	
	(Name, License Number of Sponsoring Insp	ector)

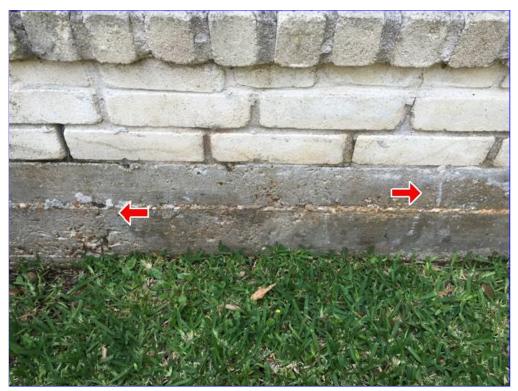
A. Item 3(Picture) Hairline cracks in foundation on right side of home.

With cracks in foundation, cracks in the kitchen tile, cracks in the ceiling near the kitchen and the sloping floor at the front right bedroom, it is recommended that a structural engineer inspect the foundation further to determine if it is failing on the right side.

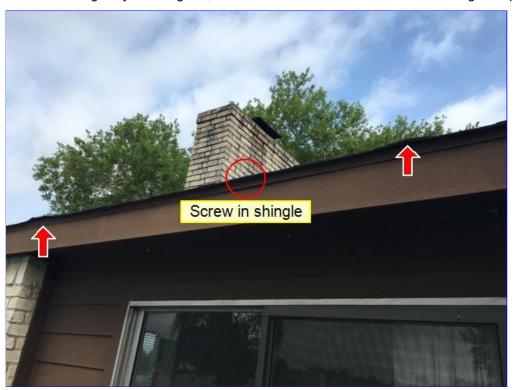
C. Item 1(Picture) Lifted shingles at rear of home. In addition screw in shingle at rear of home.

With wide spread damaged and delamination and since this home still has wood shingles and the max number of shingle layers being two, it is recommended that the roof and decking be replaced.

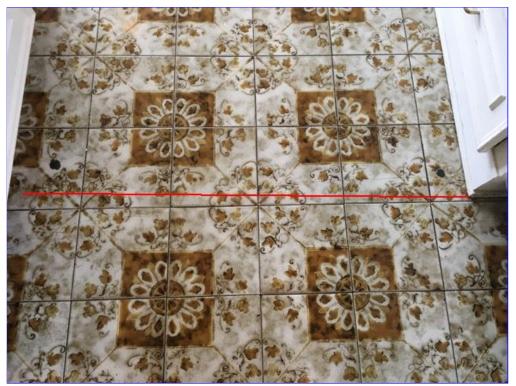
F. Item 6(Picture) Cracks in kitchen floor tile between oven and range of kitchen.

With cracks in foundation, cracks in the kitchen tile, cracks in the ceiling near the kitchen and the sloping floor at the front right bedroom, it is recommended that a structural engineer inspect the foundation further to determine if it is failing on the right side.

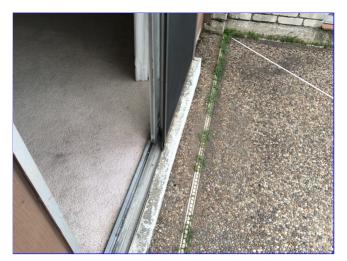
G. Item 8(Picture) Screen for sliding glass door off tracks

The sliding screen that is off tracks be re-installed and the missing screen door replaced.

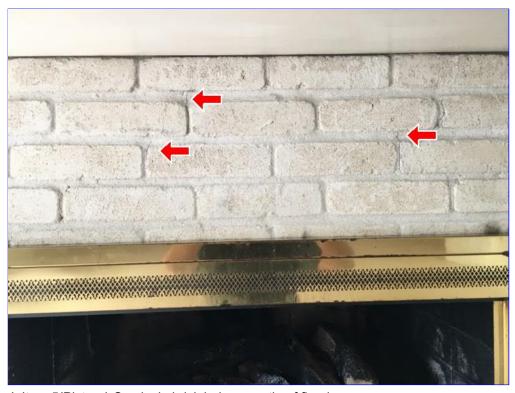
J. Item 5(Picture) Cracks in brick below mantle of fireplace.

It is recommended that all cracked brick be pointed up by a professional mason.

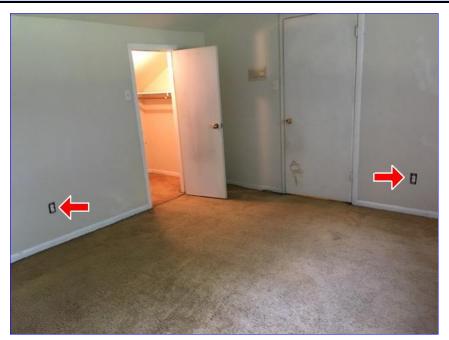
B. Item 24(Picture) Two cover plates missing for electrical outlet receptacles in upstairs right bedroom.

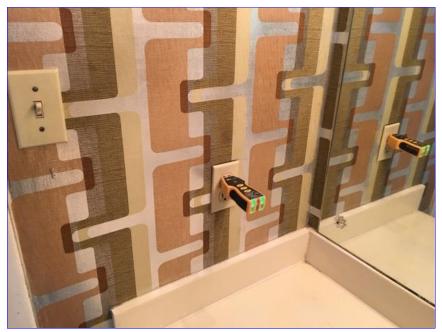
B. Item 26(Picture) Electrical outlet receptacle in upstairs hall bath not wired for GFCI.

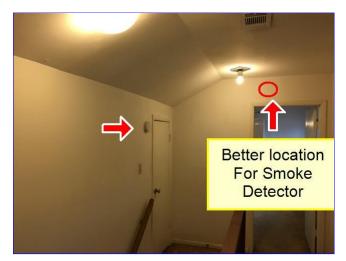
B. Item 29(Picture) Smoke detector in upstairs hallway installed in wrong location. Needs to be within 12 inches of the highest point of the ceiling.

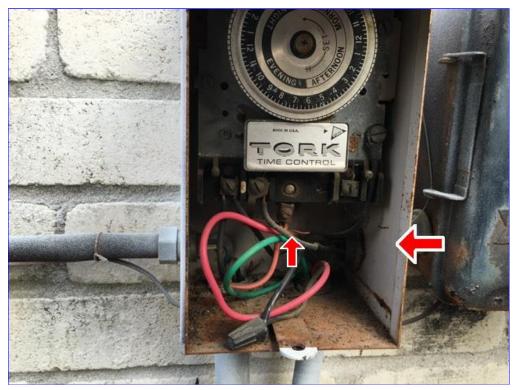
B. Item 1(Picture) Face plate missing at time control for pool. In addition Red wire not fully installed at clamp.

It is recommended that a licensed electrician inspect the electrical items listed in this section and make any necessary repairs or replacements.

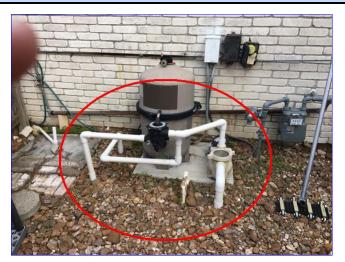
B. Item 6(Picture) It is recommended that PVC piping be painted at left side of home.

It is recommended that a professional painter or handy man paint all PVC exposed to the sun. This will help prevent it's deterioration.
